# HMAS STIRLING LOW LEVEL BRIDGE REPAIRS

GARDEN ISLAND, WA

CONCRETE REPAIRS - BRIDGES

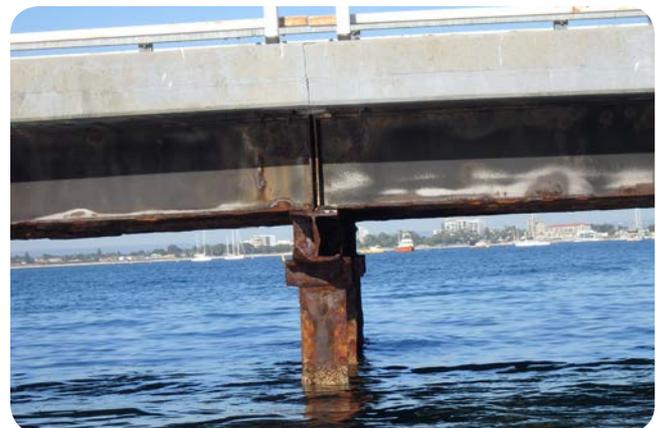
- ▶ Overview of the low level bridge.
- ▶ Original condition of the bridge structure.
- ▶ Original condition of the underside of the bridge.
